Institute for Agricultural and Forest Environment Polish Academy of Sciences

Problem of water shortage in Polish agriculture

Impact of climate change on water condition in an agricultural landscape

Improvement of water conditions in an agricultural landscape

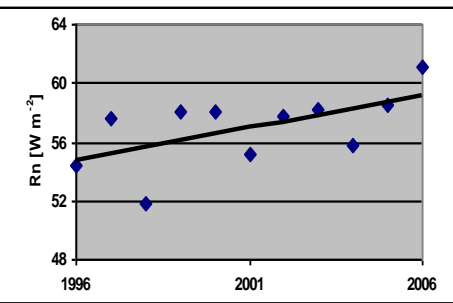
Net radiation

As a result of increase of air temperature, wind speed and relative sunshine we observed increase of:

As a result of these climatic changes during last two decades we observe lowering of water surface level in lakes by 0.5 to 1.0 m depending of land use in the catchment, and lowering of ground water level even by 3 – 4 meters.

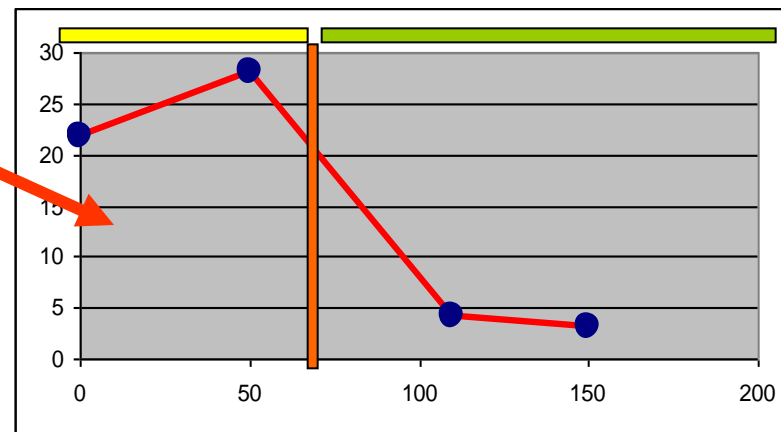
In Polish agricultural landscape concentration of nitrates in ground water under arable and was much higher than under forest.

Ground water was much more polluted than surface water

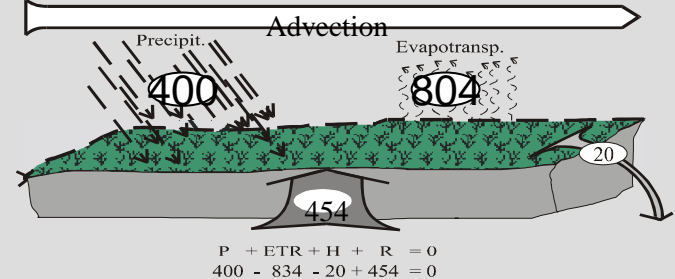
Water balance of alfalfa field without shelterbelts

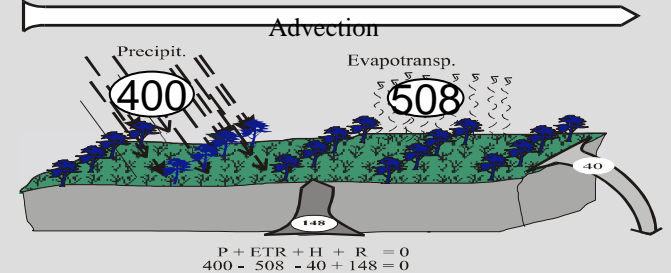
Water balance of alfalfa field with shelterbelts

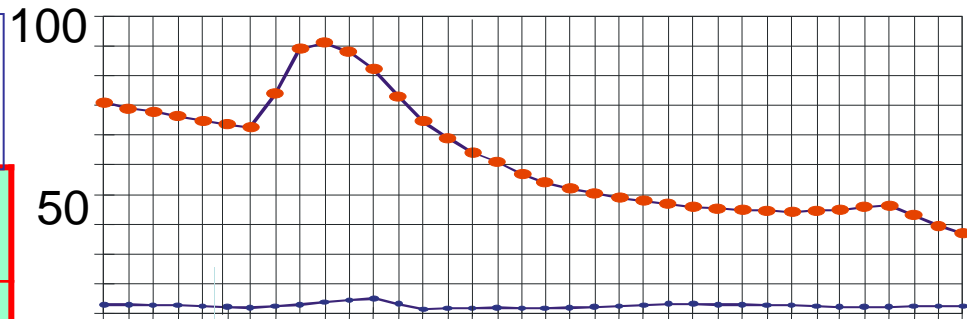
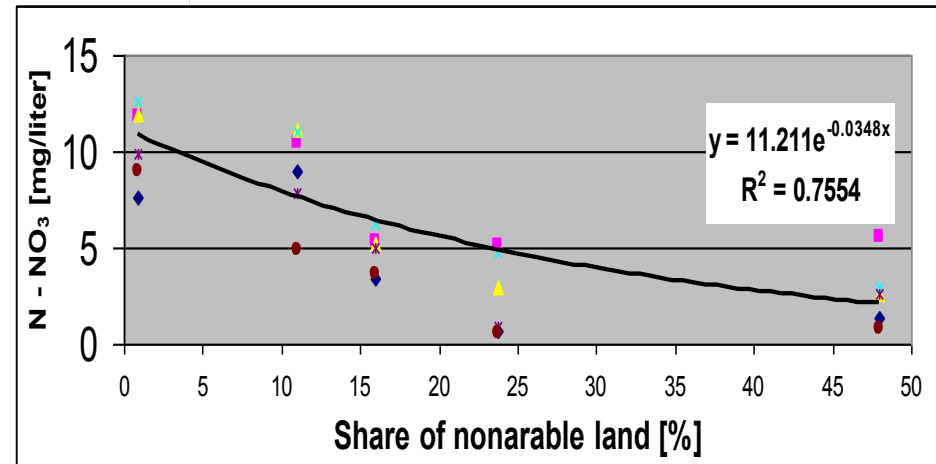
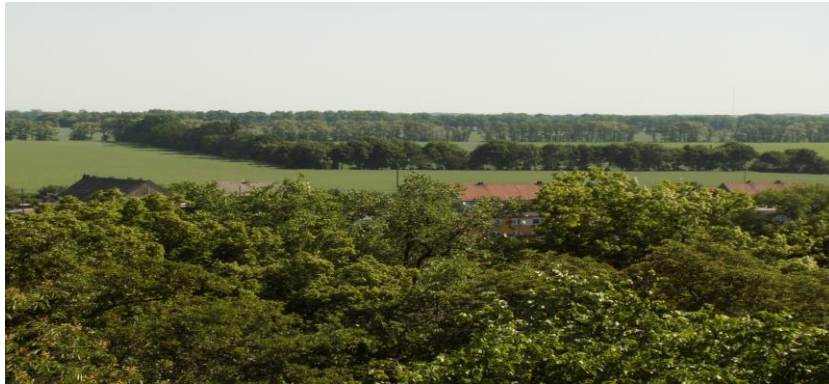
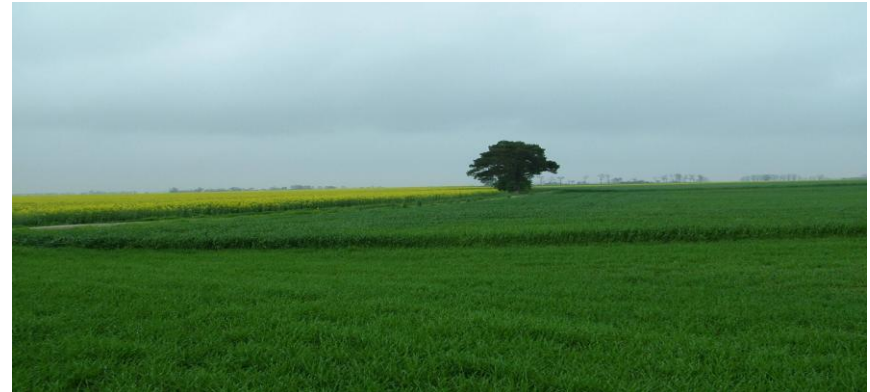
Introduction of shelterbelt net and increasing landscape complexity is one of the best tool for control of non point pollution

On a yearly basis, the amount of nitrogen (nitrates and ammonia together) leaching from one hectare of uniform landscape reached as much as about 200 kg, while from the mosaic one it amounted to only 20 kg. In the latter, higher doses of fertilizers can be applied without negative effects on water quality than in homogenous ones.
